LEAD DELINEATION & REMEDIATION AT FORMER FIRING RANGE

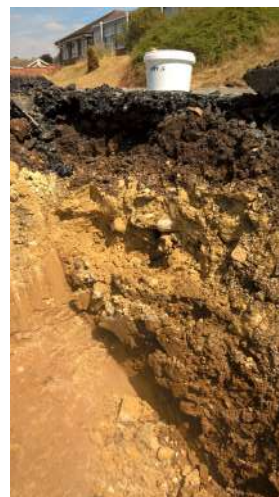
Delineation Lead distribution

The delineation was undertaken in 'layers' on a 4m sampling grid. Each layer being removed and segregated into low, medium and high impact materials.

A process of detailed delineation showed the distribution of lead could be tightly defined to small hotspots within the range area. Field XRF was evaluated as method of evaluation, however single analyte analysis at an accredited laboratory was chosen as the testing method due to its low cost, simplicity and ability to produce an accredited result.

The most highly impacted material was reduced to less than 25% of the overall volume of the soil in the range for very little additional processing cost over a bulk excavation method.
